RE: Town of Williamsport Mayor & Town Council Transportation Priorities

United States Route 11 Bridge

**Williamsport, Maryland US 11 Bridge
Planning and Environmental Linkages (PEL)
(2023 JCR, p. 79)**

**A Report for the Maryland General Assembly
Senate Budget and Taxation Committee
and
House Appropriations Committee**

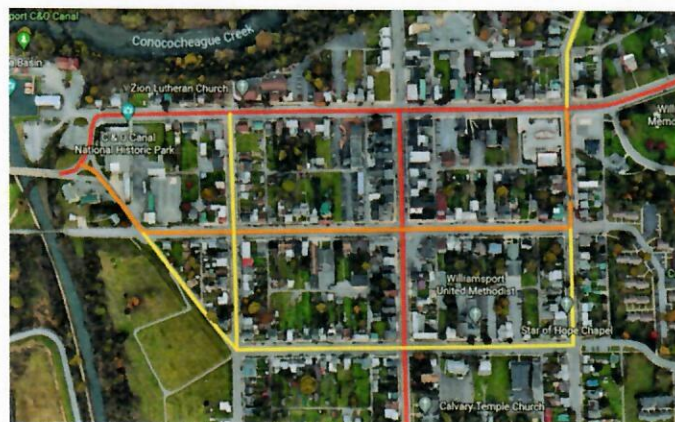
The Need: When there is an accident on Interstate 81, which is frequent, the image shows the impact on local infrastructure. Interstate traffic will use Exit 1 and Exit 2 to avoid an accident; town streets are not built to handle interstate traffic weights and amounts.
